WINNIPAUK DAM
(A/K/A/ FLOCK PROCESS DAM)
CT 00531

NORWALK RIVER BASIN
NORWALK, CONNECTICUT

PHASE I INSPECTION REPORT
NATIONAL DAM INSPECTION PROGRAM

Re: Winnipauk Dam (a/k/a Flock Process Dam)
Norwalk, Connecticut

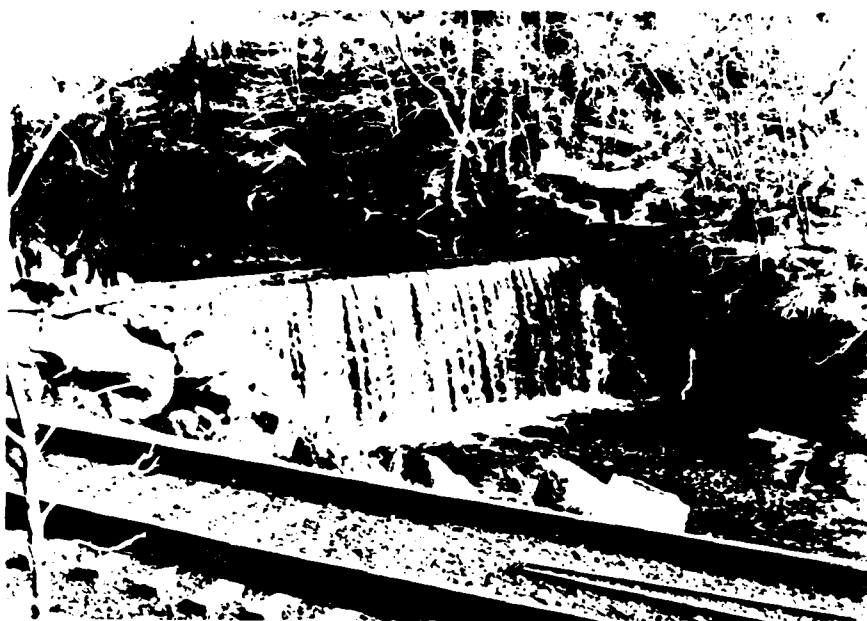
PHOTO NO. 1

The Winnipauk Dam is a run-of-the-river dam consisting of a stone masonry wall with a concrete cap and an upstream earth embankment. The dam has an overflow crest length of 75 feet, a maximum height of 22 feet and outlet works at the left abutment, Overview Photo and Photo 1. The right abutment is a ledge outcrop, Photo 2. A railroad line runs along the right abutment, Photo 1.

There was 0.3 feet of water going over the spillway at the time of inspection, so the condition of the stone masonry wall could not be observed. The concrete weir appeared to be in fair condition. The weir had what looked to be wood planking on both the upstream and downstream edges.

SPILLWAY

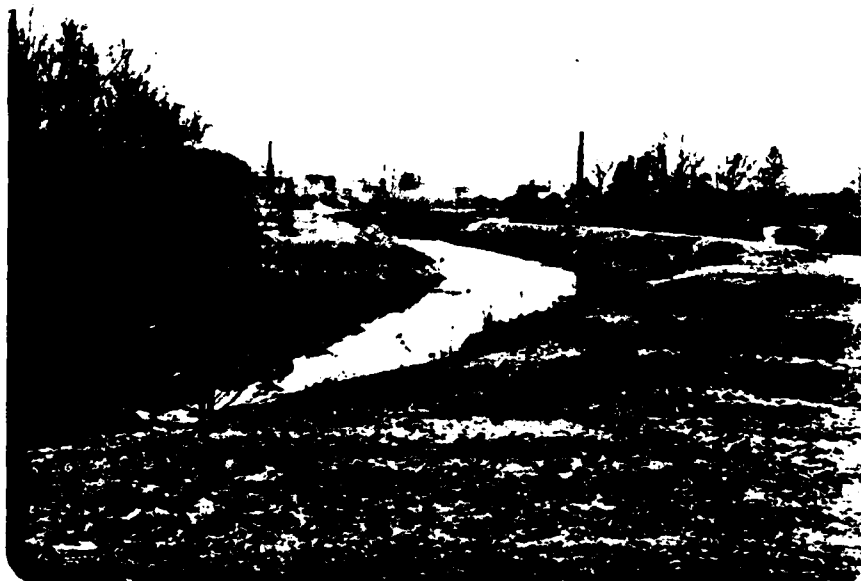
PHOTO NO. 6

RIVER CHANNEL LOOKING DOWNSTREAM
FROM RAILROAD BRIDGE.

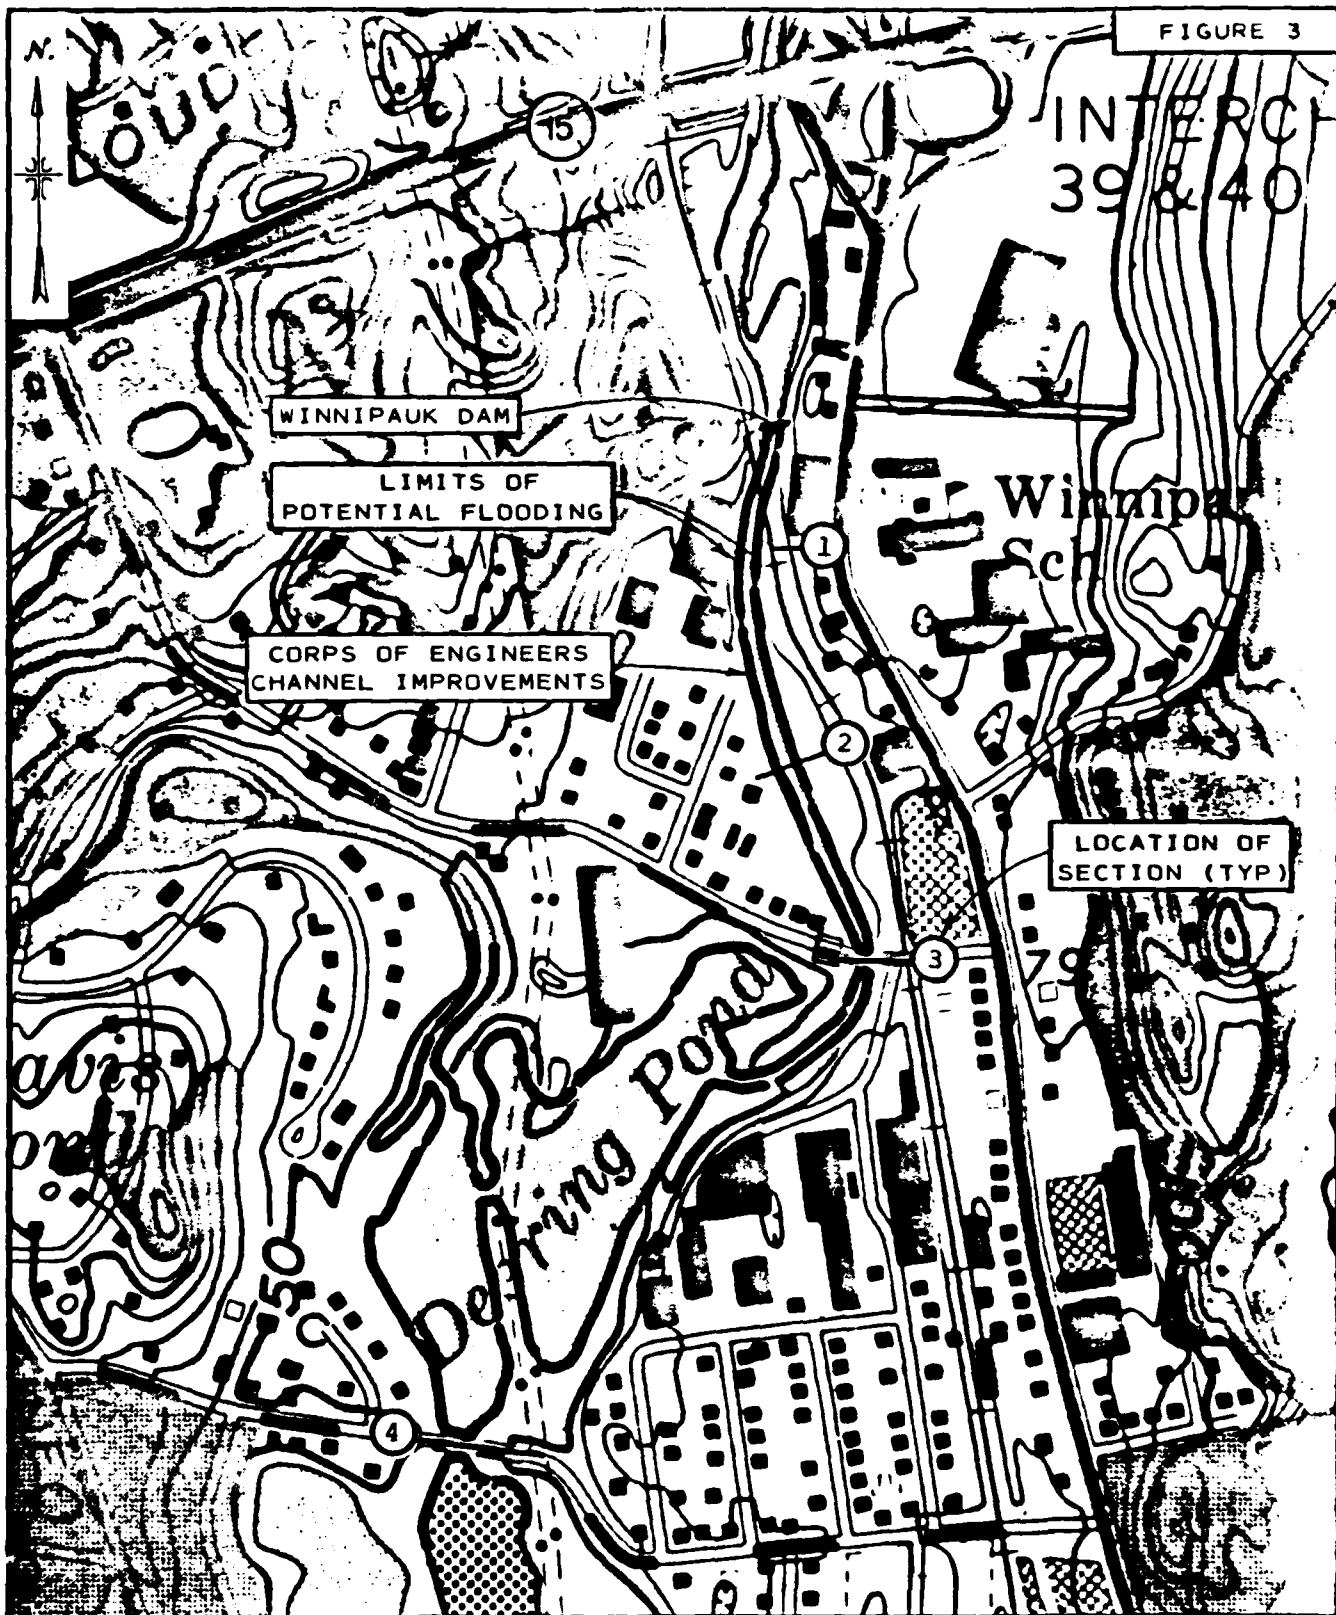
Figure 2

LIMITS OF POTENTIAL FLOODING
WINNIPAUK DAM

FAILURE WITH WATER LEVEL AT TOP OF DAM
